PHASE I ENVIRONMENTAL SITE ASSESSMENT

Former Pleviak Elementary School 304 East Grand Avenue Lake Villa, Illinois

True North Consultants, Inc. 1000 E. Warrenville Road, Ste. 140 Naperville, IL 60563

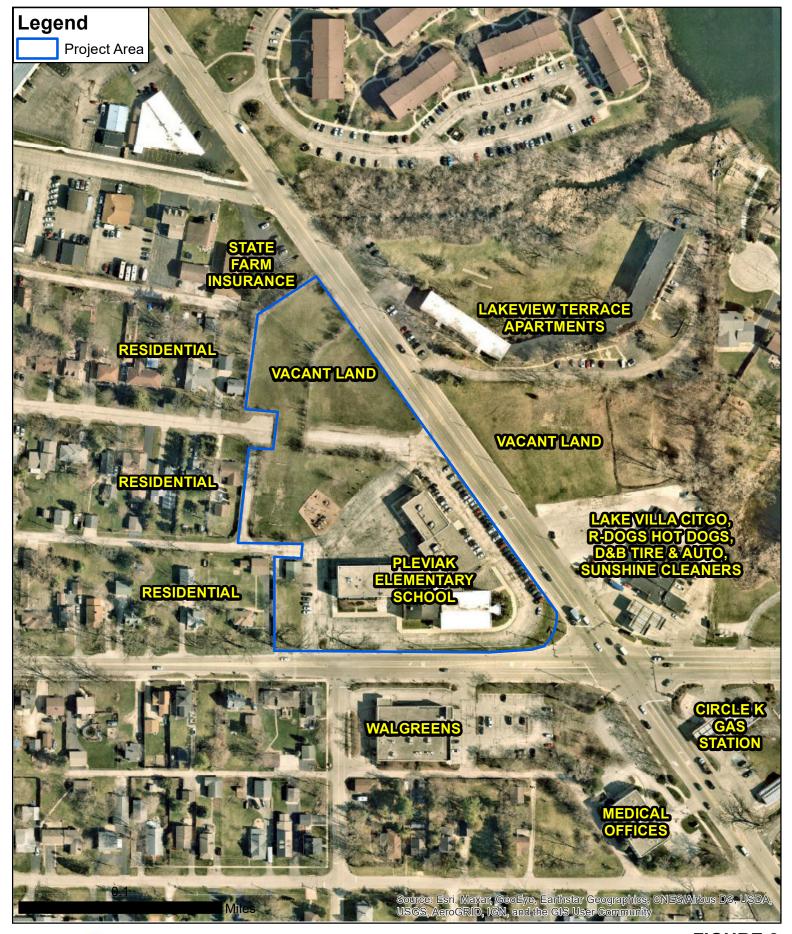
FIGURE 2

Subject Property and Surrounding Land Use Map

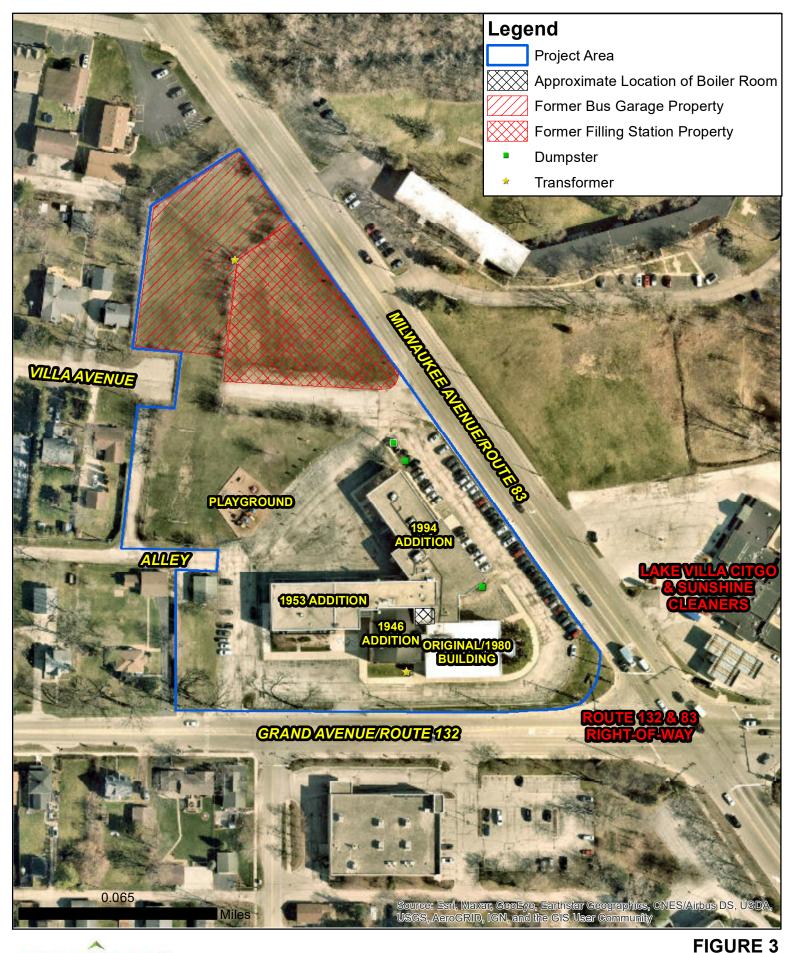
FIGURE 3 Subject Property Detail Map

Subject Property Detail Map
Former Pleviak Elementary School
304 East Grand Avenue, Lake Villa, Illinois

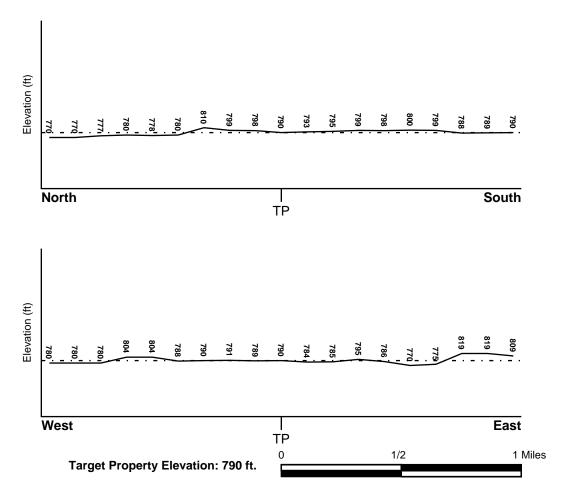
SURROUNDING TOPOGRAPHY: ELEVATION PROFILES

General Topographic Gradient: General ESE

Source: Topography has been determined from the USGS 7.5' Digital Elevation Model and should be evaluated on a relative (not an absolute) basis. Relative elevation information between sites of close proximity should be field verified.

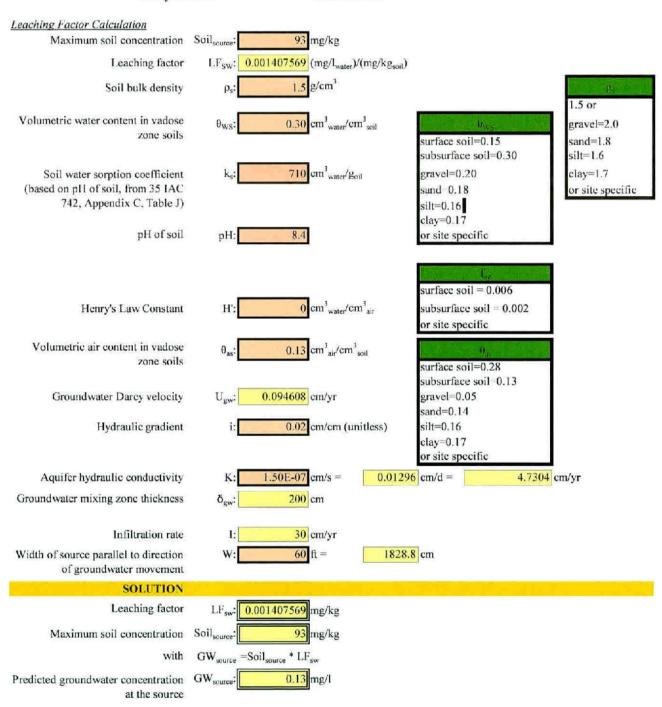
RBCA Equations R14/R26

Predicted Downgradient Concentration Based On COC Leaching From Soil RBCA Equations R14 and R26

Exposure Route: predicted downgradient groundwater concentration of COC leached from soil

Analyte: Lead Location: NW

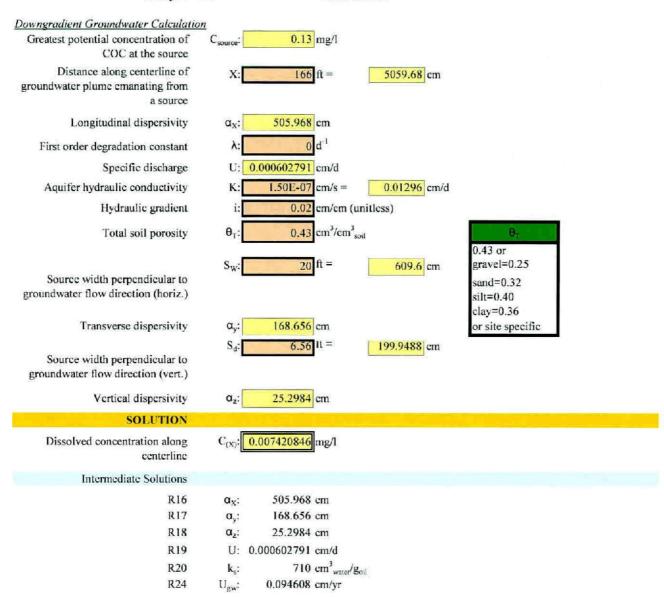
RBCA Equations R14/R26

Site: Lake Villa LUST

Exposure Route: predicted downgradient groundwater concentration of COC leached from soil

Analyte: Lead Location: NW
